ATM Card Skimming and PIN capturing Awareness Guide

Prepared by Simon Grubisic-Protective Security Advisor

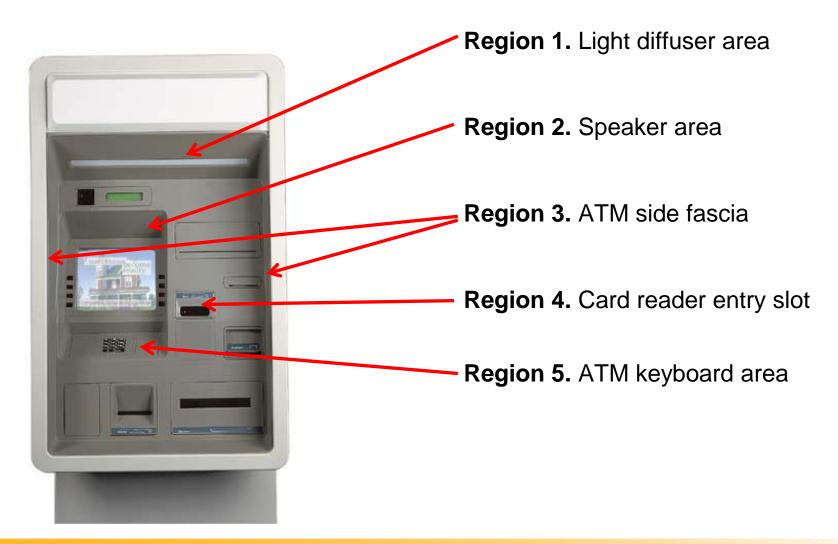
Can you tell if this ATM machine has a skimming device fitted to the card reader?

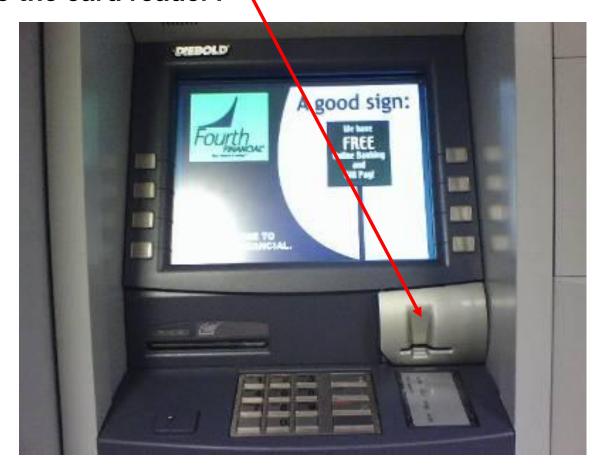
Spot the difference...Can you tell now?

• Top photo shows an unadulterated ATM fascia. The flashing lead through entry indicator is easily observed.

Note: Most skim devices when fitted will obscure the flashing entry indicator this should be a vital clue as to any suspect tampering.

• A skim device has been placed in or near the card reader slot. Although the device has been given the appearance of being a standard part of the terminal it is in fact and additional fitted piece & clearly is different from the above photo.

Note: No flashing lead through light can be seen.

The shape of the bezel is clearly different.

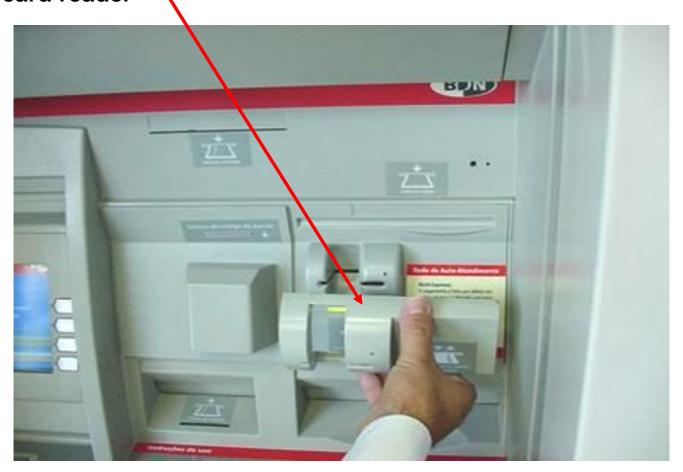
Here we have another example of the skimming device being piggy-backed onto the card reader

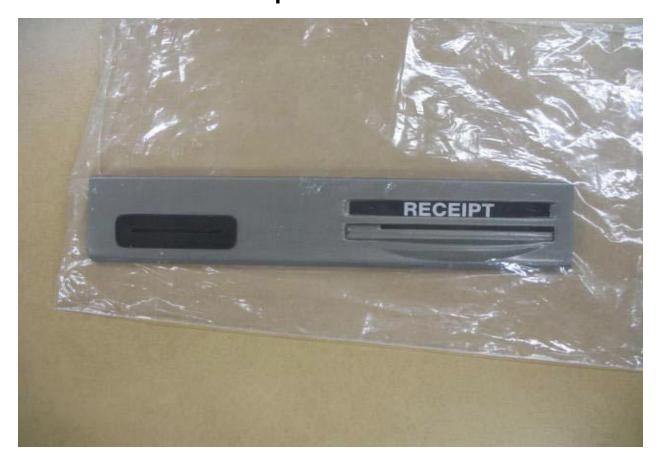
Here we have another example of a skimming device installed within this piece of ATM fascia. This was a replacement unit found on an ATM.

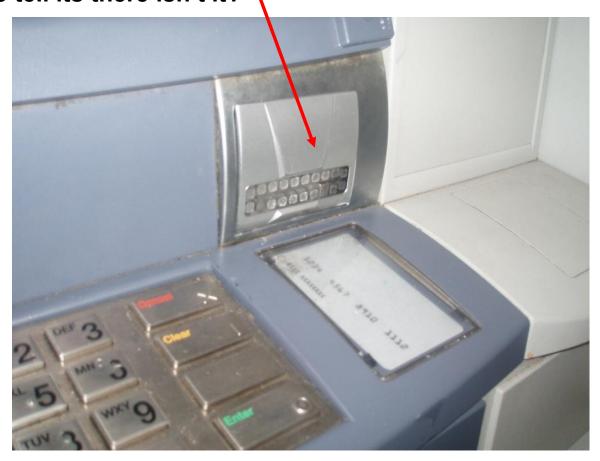
Another example of a skimming device installed on the card reader of this ATM. Hard to tell its there isn't it?

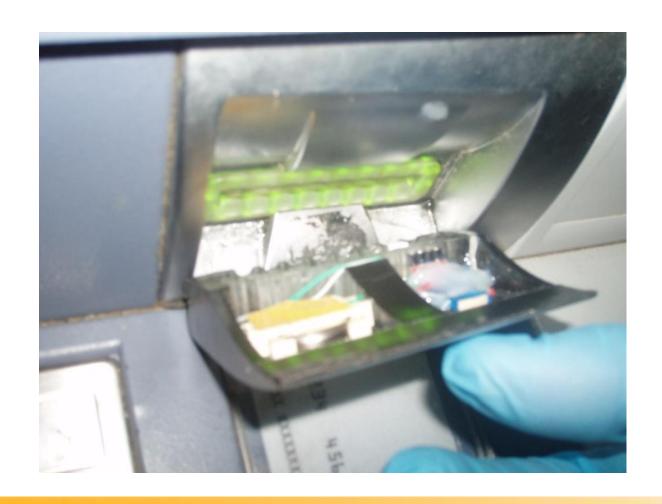
Take a closer look...

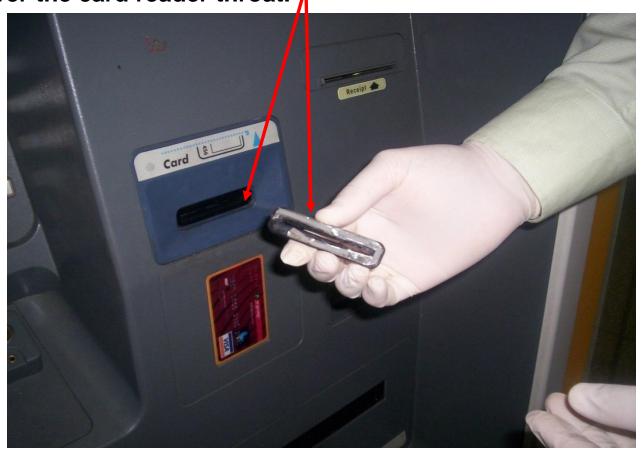
Removal of a skimming device from card reader slot, the device was fitted over the card reader throat.

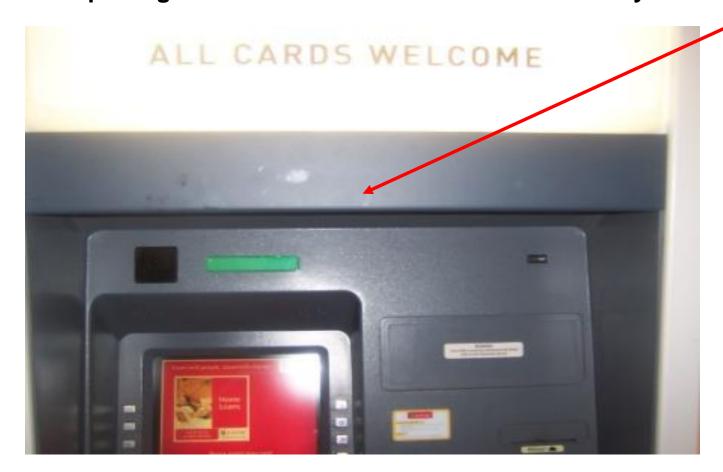
Can you tell if this ATM fascia piece (located above the screen) has a PIN capturing device installed within- You cannot really tell can you?

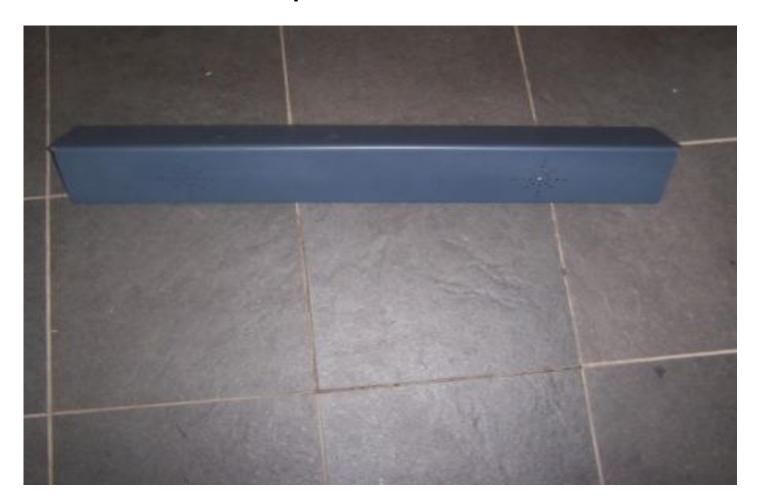
Lets remove the ATM fascia piece for a closer look.

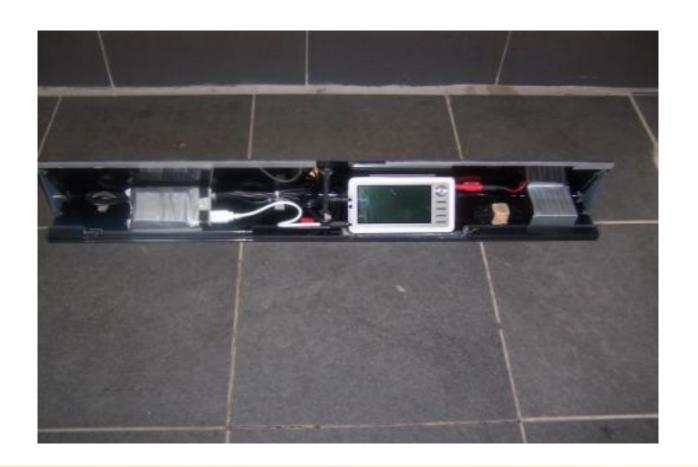
Here you can clearly see the PIN capturing device installed on the inner side of the fascia piece.

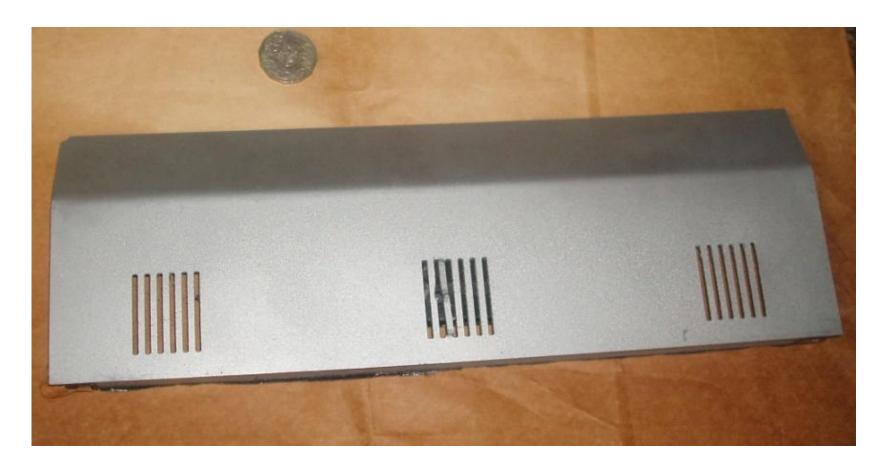
Another example of a PIN capturing device installed on the inner side of the light diffuser fascia piece (above the ATM screen). Can you see the camera?

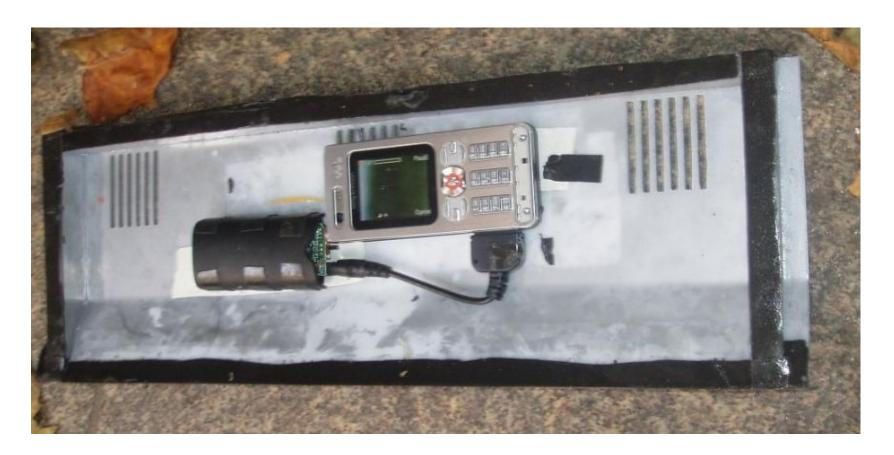
Lets have a look on the inner side. A mobile phone camera was used as a PIN capturing device, with the information being transmitted via a wireless device.

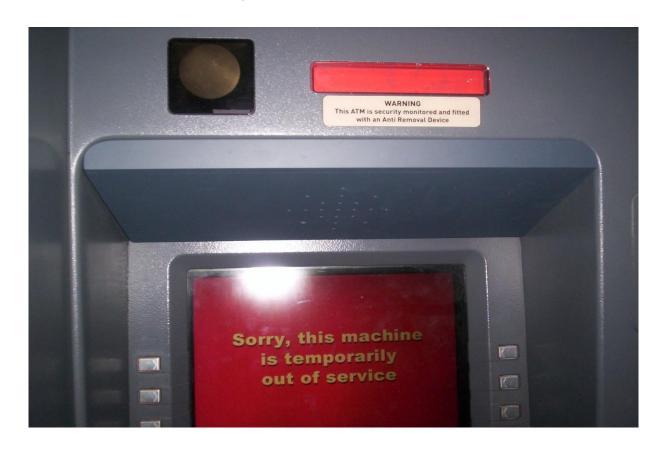
Here we have an additional fascia piece fitted to the speaker area directly above the screen- can you see this additional piece?

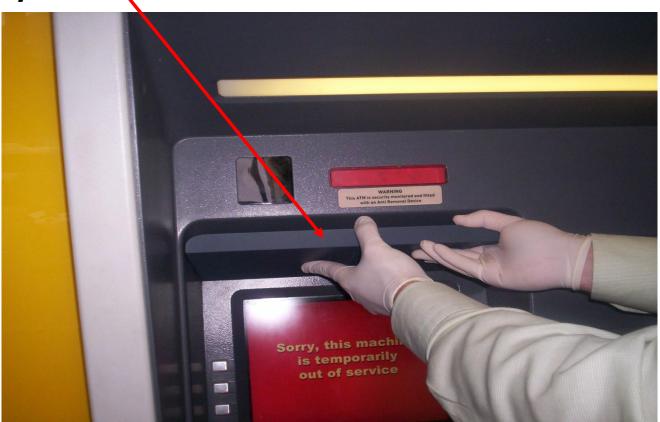
How about now?

Removal of fitted device from fascia- the additional part can now be clearly seen.

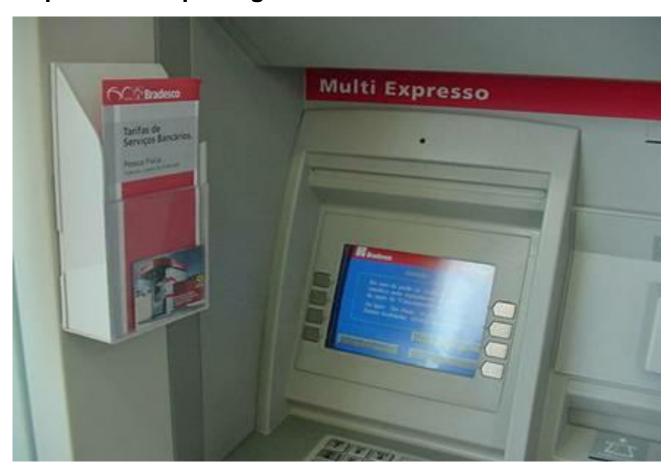
Here we have a piece of merchandising placed on the side ATM fascia wall. Can you spot a PIN capturing device?

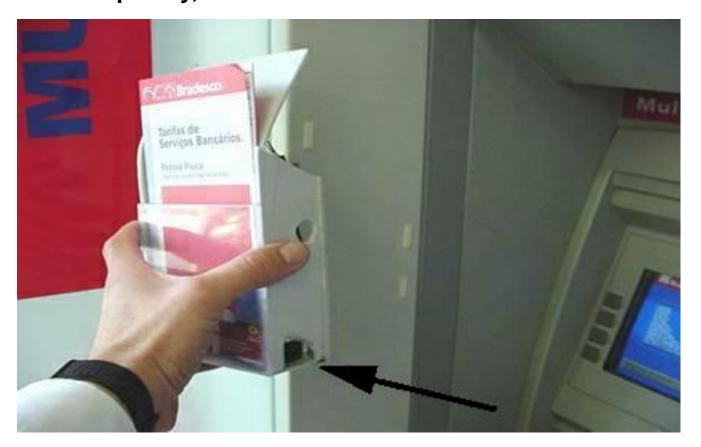
Upon closer inspection of the merchandising unit, you can clearly see the pin hole camera installed on the bottom side, capturing an image of the keypad and subsequently, the customers PIN

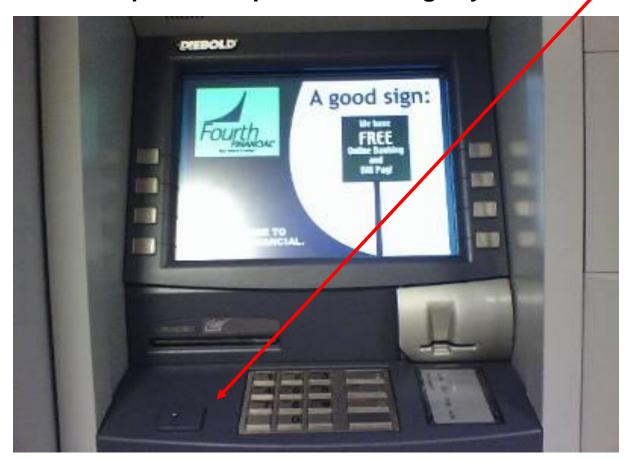
The last area of focus is the ATM keyboard fascia. Offenders are known to place the skimmer plate on top of the existing keyboard.

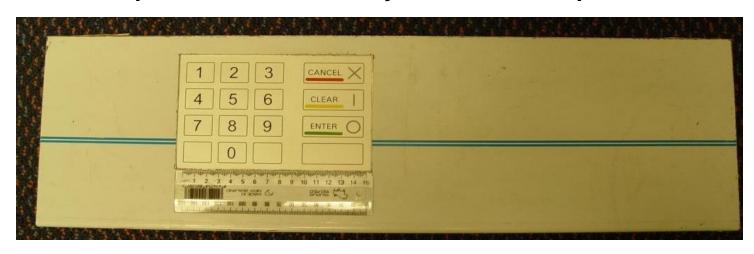
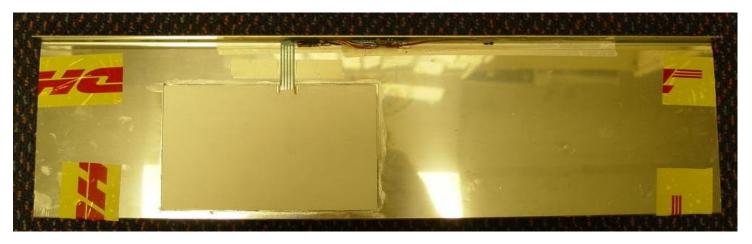
This is an example of what an ATM keyboard skimmer plate can look like.
